WATER CROSSING VISUAL INSPECTION FORM

Inspection Completed by:	Absolute Locating Employee	File Name: (Area_LSD)	15-20-2-14W2
Date Report was Generated: (DDMMYYYY)	19/01/2023	Frequency of Inspection (Monthly, etc.):	Initial

Field / Area:	Oungre	Location: (From)	XX-XX-XX-XXW2	Location: (To)	XX-XX-XX-XXW2
Licence(s) No:	XXXXXX	Line No:	1	GPS Location:	49.291840311 -102.259755214
Fluid Carried:	Emulsion	Pipe Size (O.D. mm)	114.30 mm	River:	
Survey Map Location:	XX-XX-XX-XXW2	Watercourse Type:	Creek Crossing

COMPANY NAME
COMPANY-AREA-XX-XX-XX-XX W2M
WATER CROSSING DEPTH OF COVER SURVEY
PIPELINE XXXXXX-1

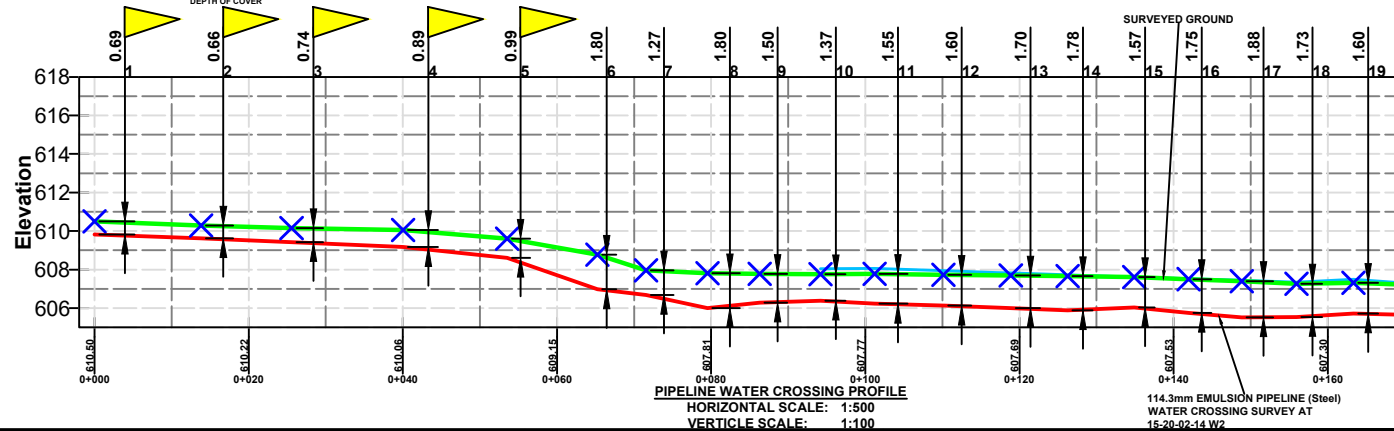
PIPELINE WATER CROSSING PROFILE
HORIZONTAL SCALE: 1:500
VERTICLE SCALE: 1:100

Line Depth (m):	0.66m was the shallowest depth		
Report Originator:	Originator	Position:	Locator/Drone Pilot
Date:	Jan 19/2023
